## Scale Control in Two-Mile-Long Wastewater Line at Beef Hide Tannery

FTC-1600 installed January 25, 2018

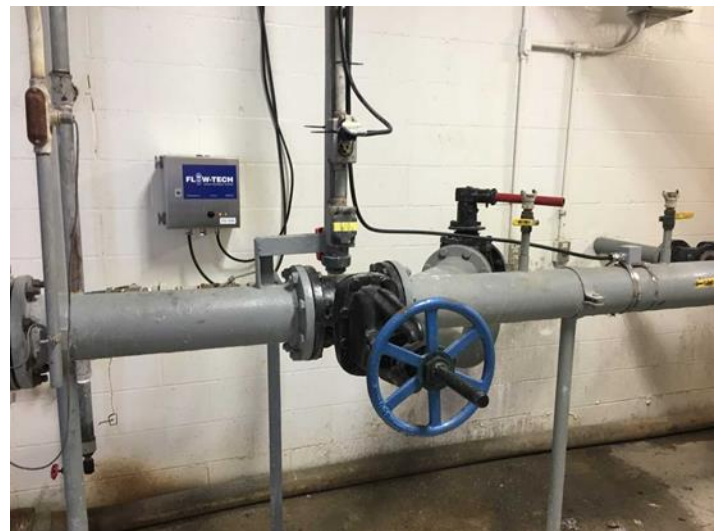
As seen from the data collected January 25 through April 12 in the table below, the flow rate oscillated between 183 and 196 gpm for the remainder of the study. If the flow rate had decreased, it would have indicated that the Flow-Tech treatment was not inhibiting deposit formation—as the flow rate consistently decreased without any treatment. Because the flow rate remained relatively steady, this demonstrates that the Flow-Tech technology is inhibiting further deposit build-up in the line.

### Flow Rate in Flow-Tech Treated Line

Performance was monitored with weekly flow rate measurements at a fixed pumping pressure of 30 psi. Immediately after the line has been jetted, the flow rate at 30 psi is typically about 500 gallons per minute (gpm). At the time of installation of the Flow-Tech system, the flow rate was 172 gpm, indicating significant deposit built up inside the line. After one week of Flow-Tech treatment, the flow rate increased to 196 gpm, indicating that some deposits were removed.
